AW189 Technical Briefing
Dhanaraj Eliyathamby (Dhana)

In Service Events

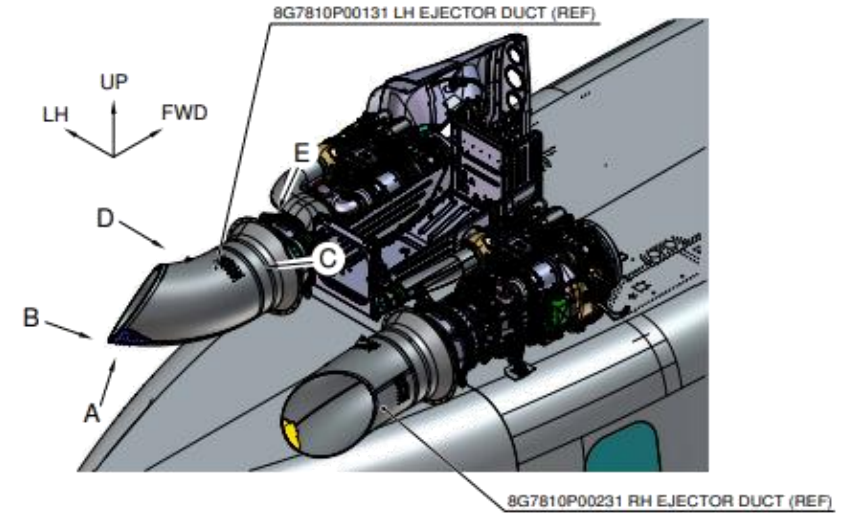
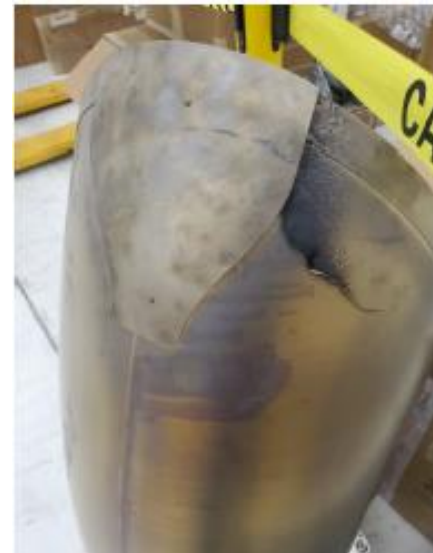
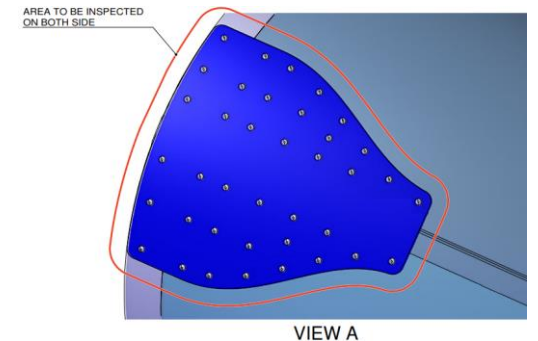
Ejector Ducts Inspection

- Cases of crack reported on the rear portion of the Ejector (LH P/N 8G7810P00131).
- The crack usually originates close to the edge line of the reinforcement plate.
- If undetected, the damage could lead to material detachment, as occurred to one Operator.

- ✓ **SB189-384** was released in July 2023 as a precautionary measure to detect cracks.
- Investigation is currently ongoing on several cores returned to LH and on affected H/C.
- In light of feedback from the field, an **SB189-384 Rev.A** shall be published to introduce inspection of the exhaust brackets (**Q4 2024**).

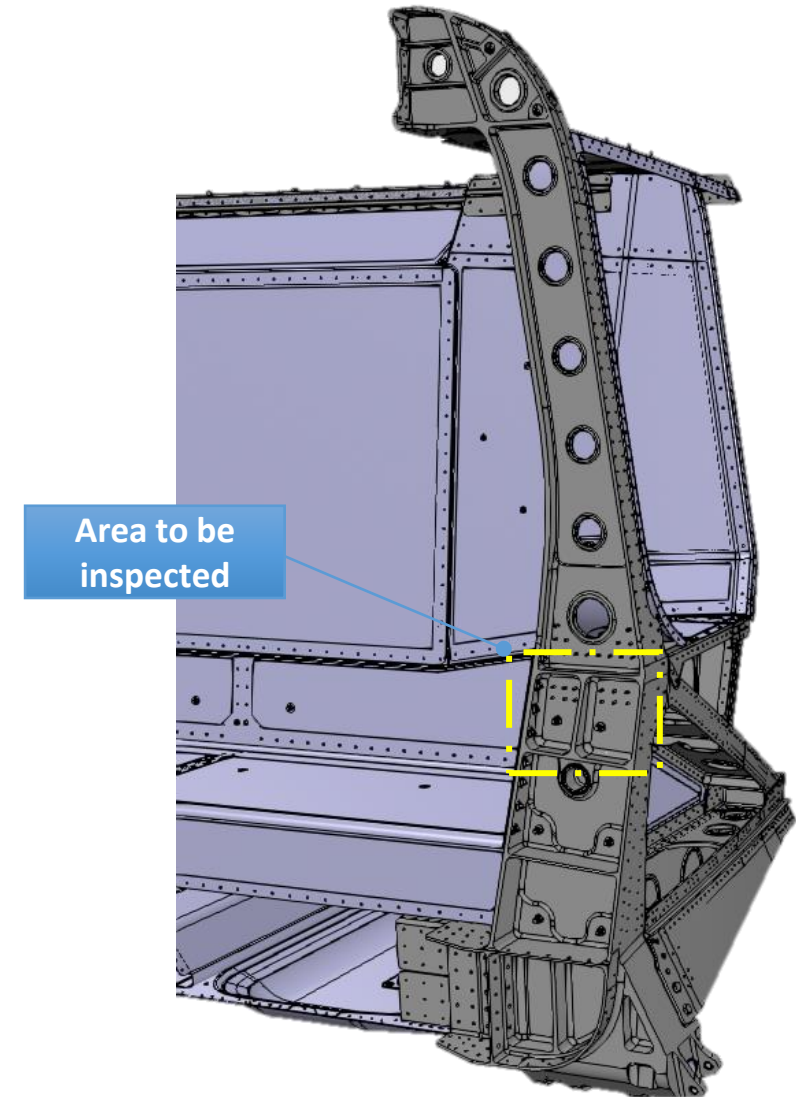
Frame STA 5700, MLG Slant Beam Attachment

- Following a review of AMPI Chapter 4 requirements, it was found an additional inspection of the frame STA5700 is required for helicopters with more than 14.765 landings.
- Technical Information Letter **T-189-24-003 released in July 2024** to inform all operators of the requirements.

- ✓ **SB189-397 released in August 2024** providing instructions to all operators to perform the inspection.
- ✓ A repetitive inspections will be required each 1160 landings.
- The inspection will be introduced in AMPI Chapter 4 at the first favorable occasion.

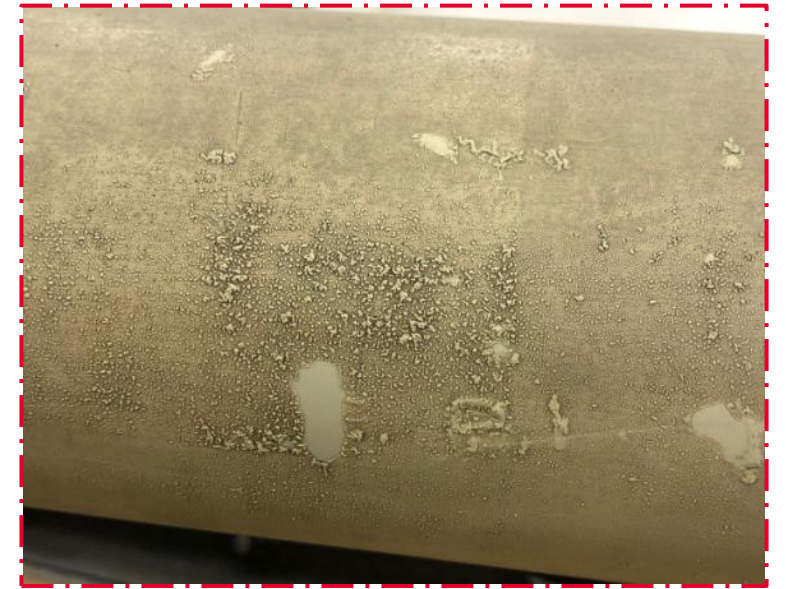
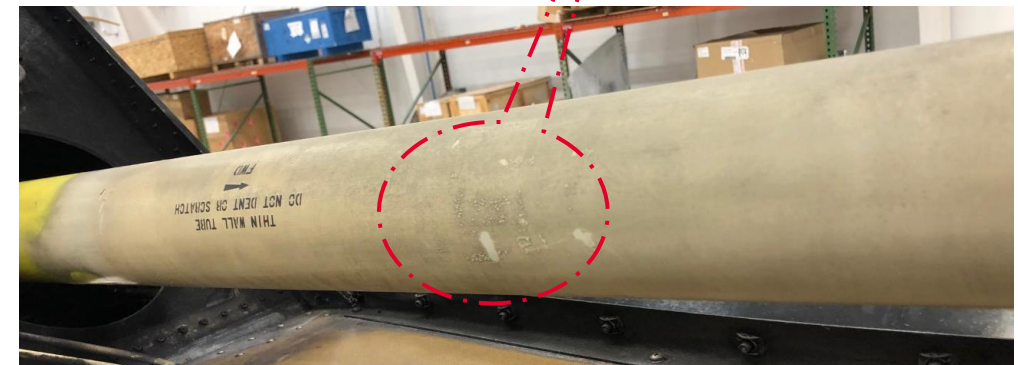
TRDS Paint Bubbling

- Cases of paint bubbling on Tail Rotor Drive shaft have been reported from field.

- Internal investigation performed on returned items identified weaknesses of XPD Primer and paint adhesion due to the sealed anodisation substrate when exposed on both high humidity and temperature.

- Changed manufacturing treatment and painting process to guarantee a better adhesion between shaft and primer.
 - Dry and Wet adhesion tests are currently ongoing for improvement confirmation.
 - **Test completion: Q4 2024**

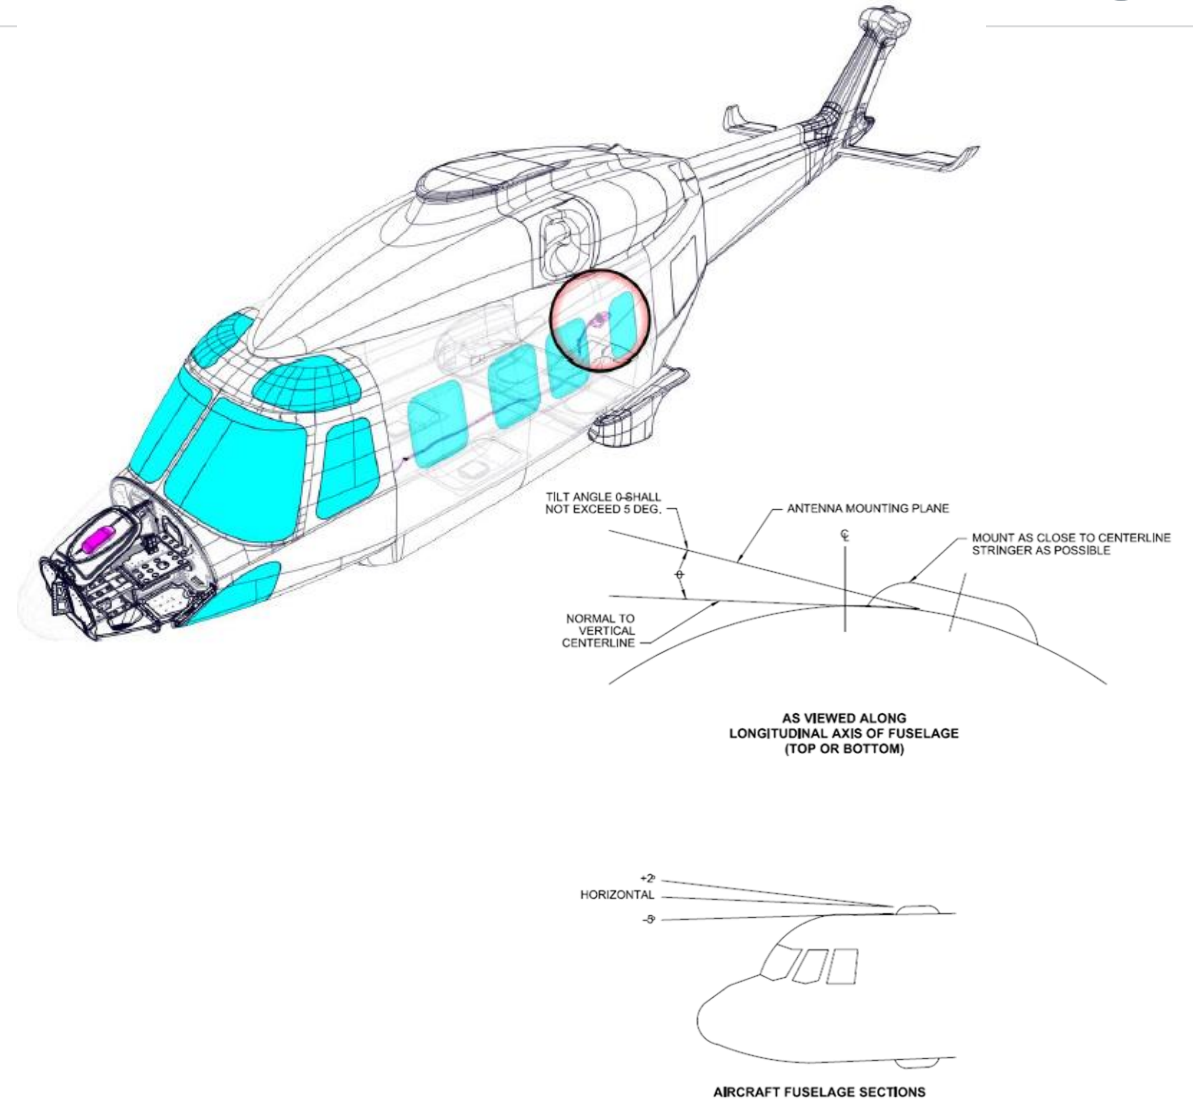
AW189 TCAS II Targets

- Customer reported cases of TCAS II targets that disappear from the screen when the target is below the helicopter level and getting close.

- An internal investigation lead to identify a possible improvement in the bottom antenna location for GER.

- The bottom antenna in the new position is under testing.
 - **Certification Forecast: Q1 2025.**
- A retromod certification and subsequent SB will be planned only after the test results.

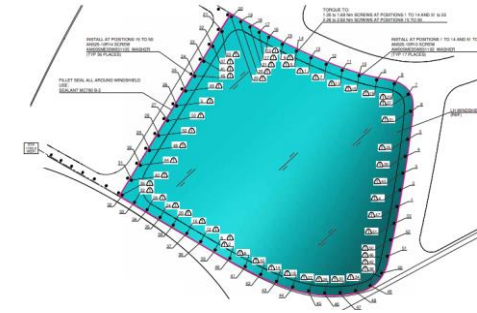
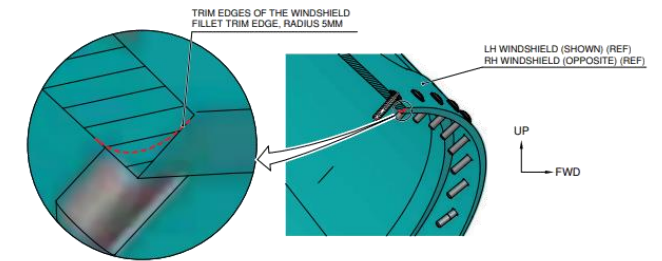
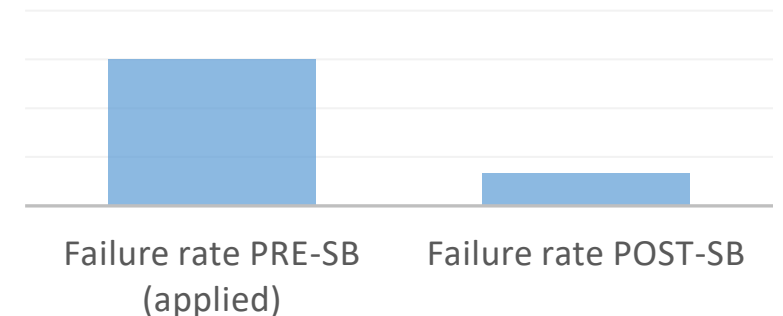
Heated Windshield Installation Improvement

- Cases of cracked glass windshields reported from service.
- Residual strength analysis of the windshield completed with no finding.
- Existing installation demonstrated susceptibility to FOD impacts and canopy deformation.
- Torquing sequence influences the windshield preload.

- ✓ Improved windshield installation in IETP and through **SB189-294** issued May 2022.
- ✓ In-service monitoring on the applicable fleet pre- and post-SB application showing a significant reduction of the windshield failure rate.
- ✓ Post-SB fleet leader accrued **2000+ FH** with no findings.
- Considering the positive feedback from AW189, similar solution is under development on AW139.

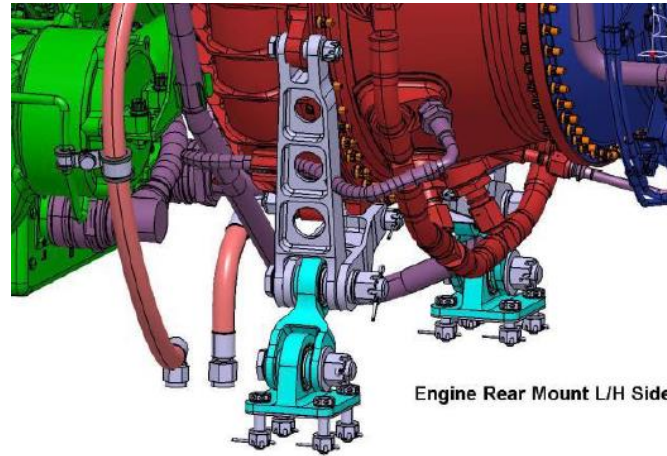
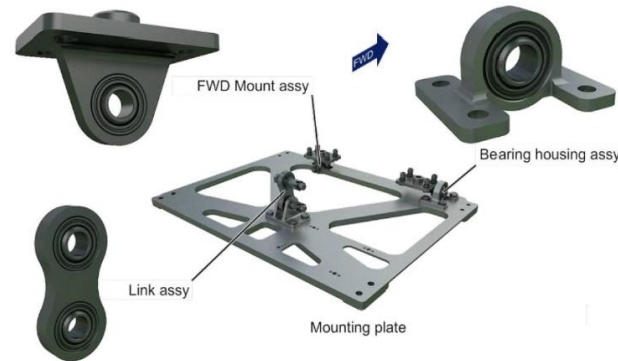
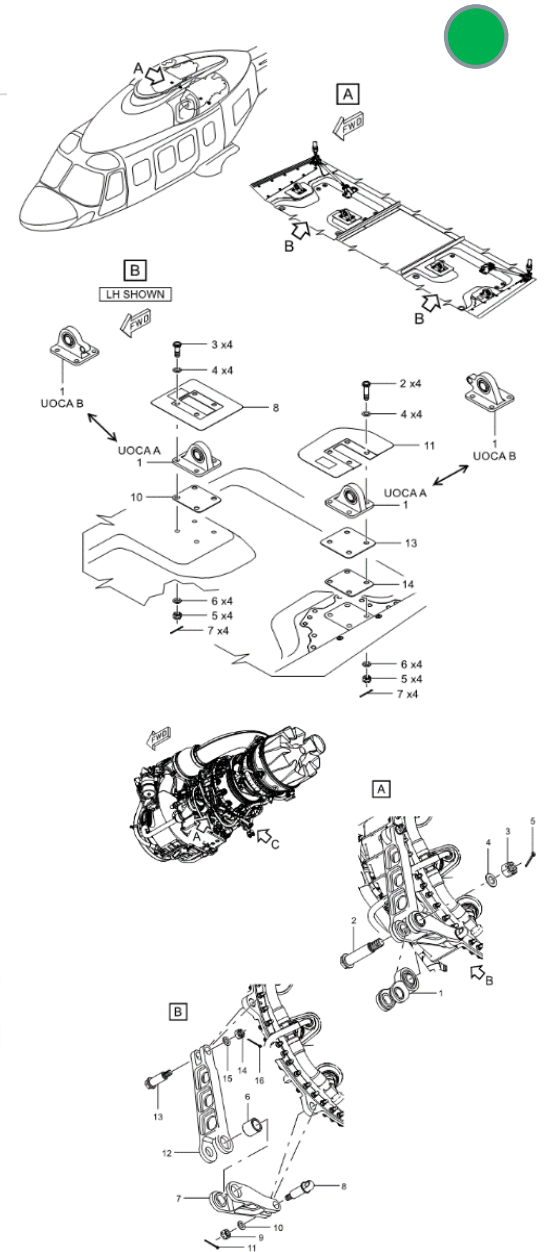
Improved Engine & APU Mounts

- Cases of corrosion on Engine and APU mount bearings reported by Operators, leading to replacement of the mounts.

- ✓ The current bearing, a standard MS14101 bearing with steel ball, has been replaced with a bearing with CREN ball and self-lubricating Teflon liner.
- ✓ The design is FFF with the current one (no SB required).
- ✓ New PNs introduced into

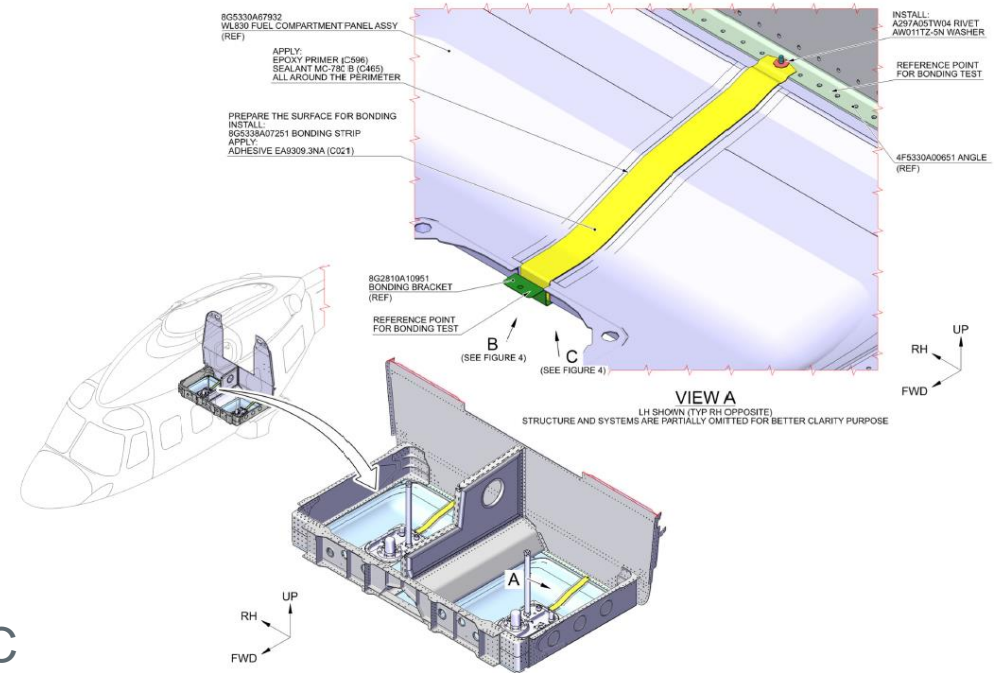
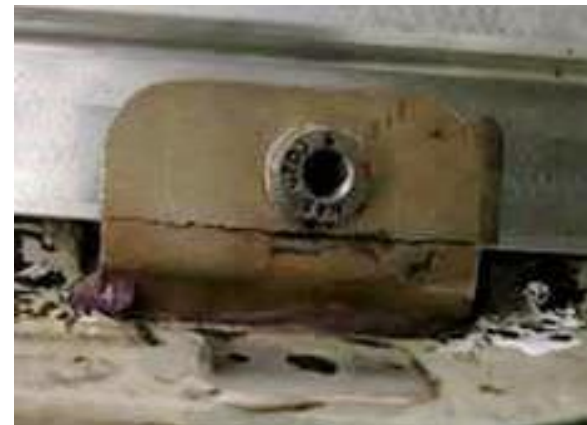
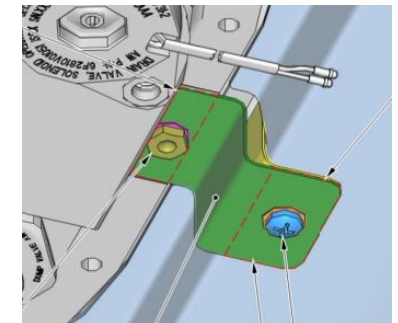
Sump Bonding Strip Installation Improvement

- Cases of corrosion, damage and cracks on the main fuel tank sump bonding bracket reported from in-service during bracket removal.

- ✓ Retromod P/N 8G5331P08111 developed in order to introduce an improved design of the fuel tank sump electrical bonding installation, allowing for a quicker replacement of the strip in case of damage.
- Deployment on new-built H/C and in-service through **SB189-370 issued November 2024**
